DECLARATION OF KAREN ASHBY IN
SUPPORT OF PLAINTIFFS' MOTION
FOR SUMMARY ADJUDICATION

California Department of Corrections / Mule Creek State Prison
Inspection Date: November 19, 2020

Appendix 4 -Photograph Log

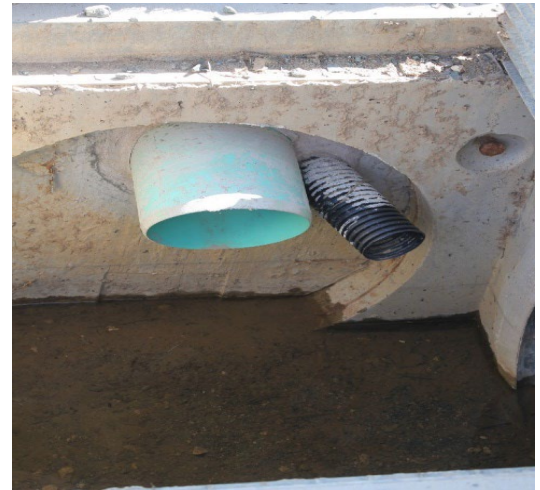
IMG-2820. Drop Inlet U/S GT-4

24 A. At the drop inlet upstream (U/S) of Guard Tower 4
25 ("GT-4") (see red square on Figure 1), I observed standing water
26 in the catch basin (IMG-2820).

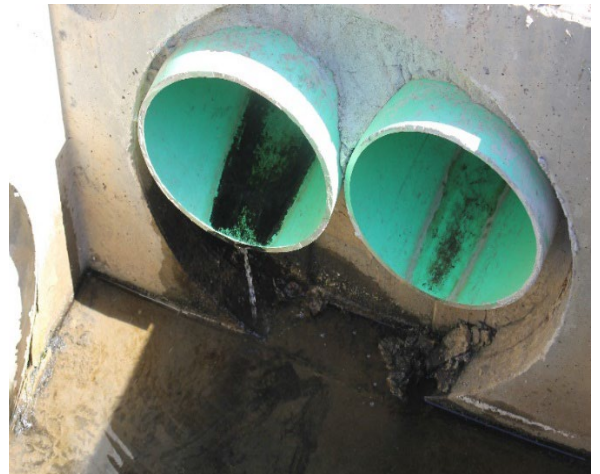
IMG-2797. Drop Inlet D/S GT-4

B. At the drop inlet downstream (D/S) GT-4 (see red square on Figure 2), I observed water actively flowing through subsurface pipelines, apparently from within the Facility, under the lethal fence, and into the catch basin located at GT-4. (IMG-2797). The County's field technician took a sample of the flowing water from the subsurface pipeline into the catch basin. I reviewed the analytical laboratory results of Plaintiffs' Lab Samples which confirmed the presence of *E. coli*, total and fecal coliform, and pharmaceutical products.

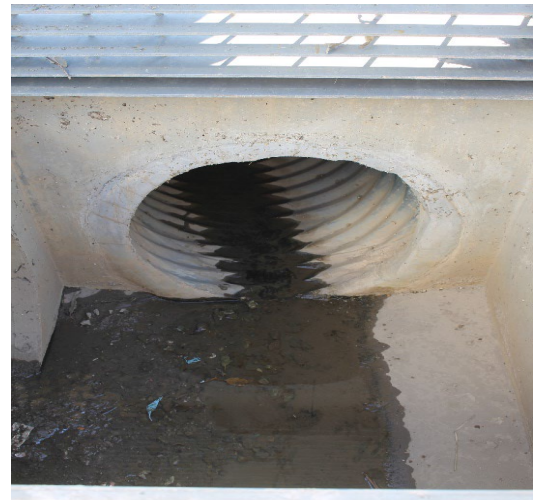
IMG-2771 - D/S GT-4, Between Bldg 4 and 5

C. Every drop inlet between GT-4 and Guard Tower 3 ("GT-3") had visible standing or flowing water present as shown in IMG-2773, 2771, and 2767. The location of each image is indicated by the red squares on Figures 3 to 5 below.

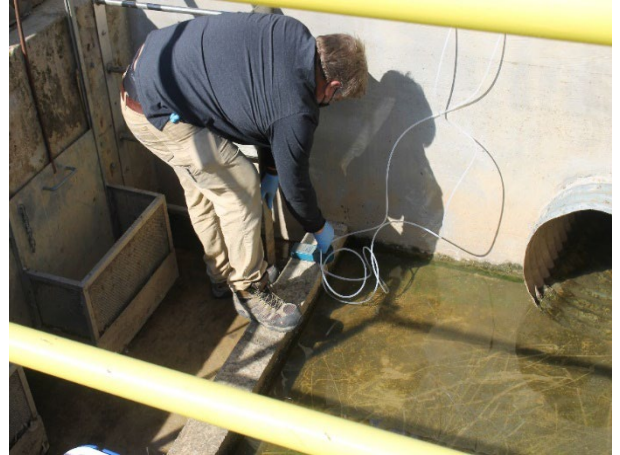
IMG-2758 - Guard Tower 3

D. At the junction vault D/S GT-3 (see red rectangle on Figure 6 below), I observed water present within the junction vault and subsurface corrugated pipelines that carry flows through the Facility's storm drain system from the direction of GT-4 to the junction vault (IMG-2758). The County's field technician took a sample of the water within the junction vault. I reviewed Plaintiffs' Lab Samples results which confirmed the presence of *E. coli*, total and fecal coliform, and

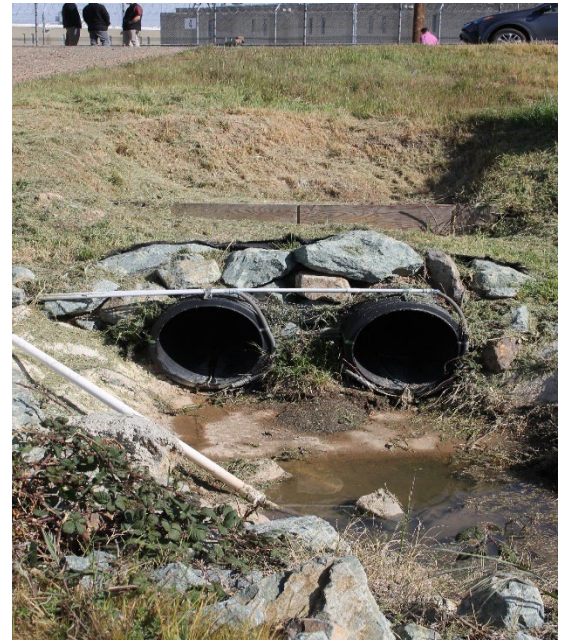
IMG-2738 - MCSP6 Outfall

E. As set forth in the Stormwater Report, flows leave the junction vault at GT-3, flow through a culvert under a perimeter road, and outfall to an earthen channel. The outfall to the earthen channel is labeled MCSP6 on Figure 6. Flows from the earthen channel enter Mule Creek at the location labeled MCSP3. (See red rectangle on Figure 7 below) I inspected the outfall at MCSP6 and found standing water in the earthen channel at the point of outfall. I also observed evidence of a recent flows through the storm drain system outfall at MCSP 6 to the earthen channel. (IMG-2738, IMG-2741).

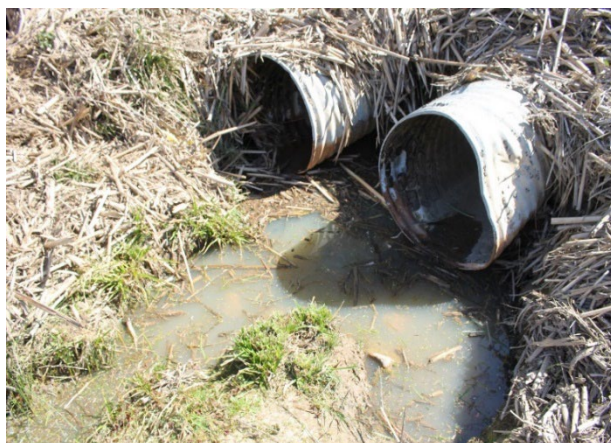
IMG-2778 - MCSP3

F. As shown in red rectangle on Figure 8 and IMG-2745, IMG-2778, and IMG-2827, I followed the earthen channel from MCSP6 to MCSP3 and observed standing water within and evidence and recent flows through large portions of the length of the channel. At the point labeled MCSP3, I observed water inside the pipelines that outfall to Mule Creek (IMG-2778).

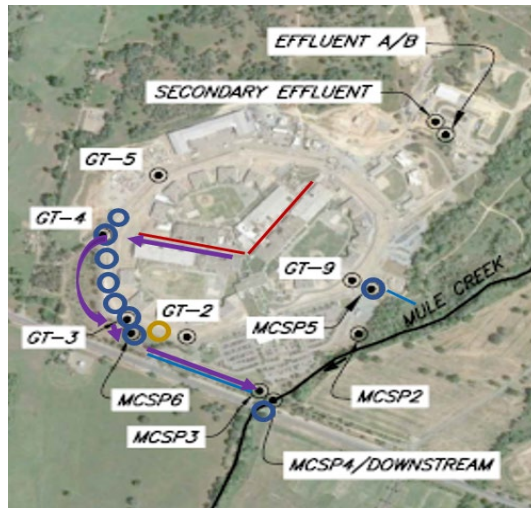
Figure 9. Observed Flows March 9, 2022

G. Based on these observations and the diagram of the flows within the Facility's storm drain system, the water within the junction vault at GT-3, which drained through MCSP6 and into the earthen channel, appeared to follow the route shown in purple on Figure 9 below.

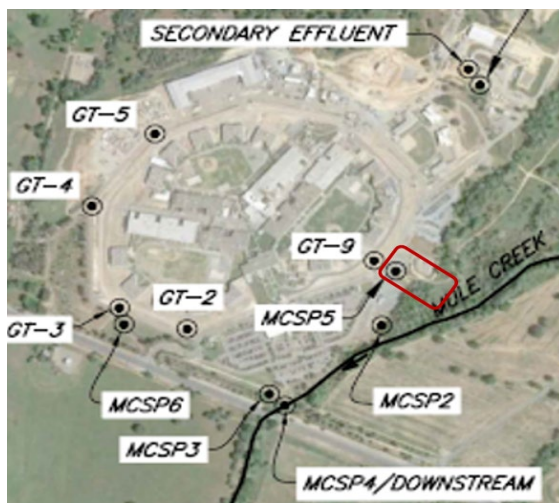
IMG-2853 - Junction Vault at MCSP5

H. At MCSP5, I observed water in the junction vault as shown red rectangle in Figure 10 and IMG-2853. I followed the path of the storm drain system across the street to the location where MCSP5 outfalls to an earthen channel. As shown in IMG-2861 and IMG-2865, there was evidence of flows recently leaving the MCSP5 outfall and there was standing water in the earthen channel that drains into Mule Creek.

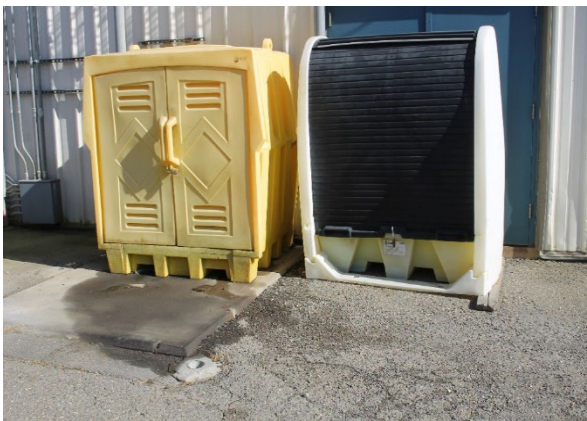
1 industrial meat packing area was leaking onto the ground in an
 2 area exposed to precipitation. According to the NEC Report, page
 3 7, figure 3, legend note 3, the chemicals stored in this area
 4 include "Hazmat 'igloos' containing food grade mineral oil for
 5 equipment lubrication." In addition, cardboard containers were
 6 stored at the edge of the covered loading dock area outside the
 7 meat packing area, in a location exposed to precipitation.

10
 11
 12
 13
 14
 15
 16
 17
 18
 19
 20 IMG-2877 - Leaking Industrial
 Material Storage

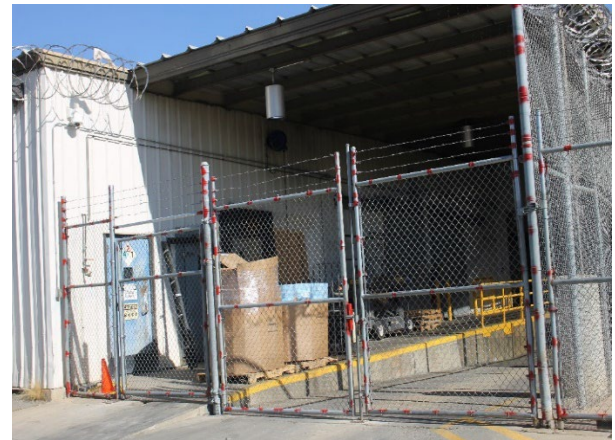
21
 22
 23
 24
 25
 26
 27
 28 IMG-2876 - Cardboard Container
 Storage

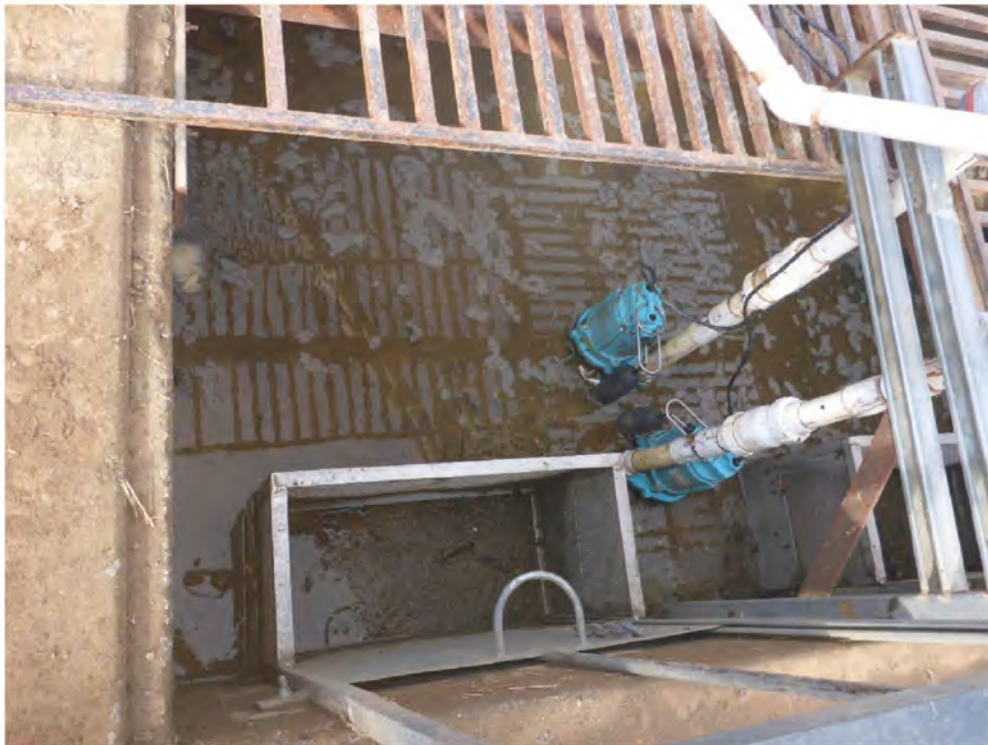
Photo 8 – Closeup of secondary junction vault with pumps, screens, and two closed slide gates.
Pumps were not operating at time of observation.

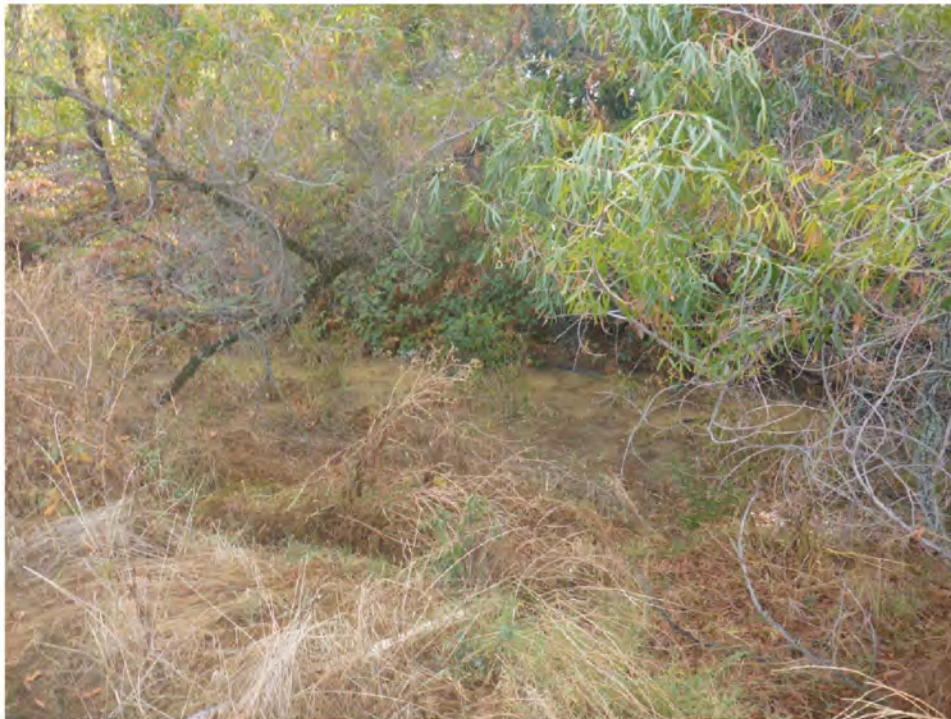
PHOTO 14 – Drainage channel with water

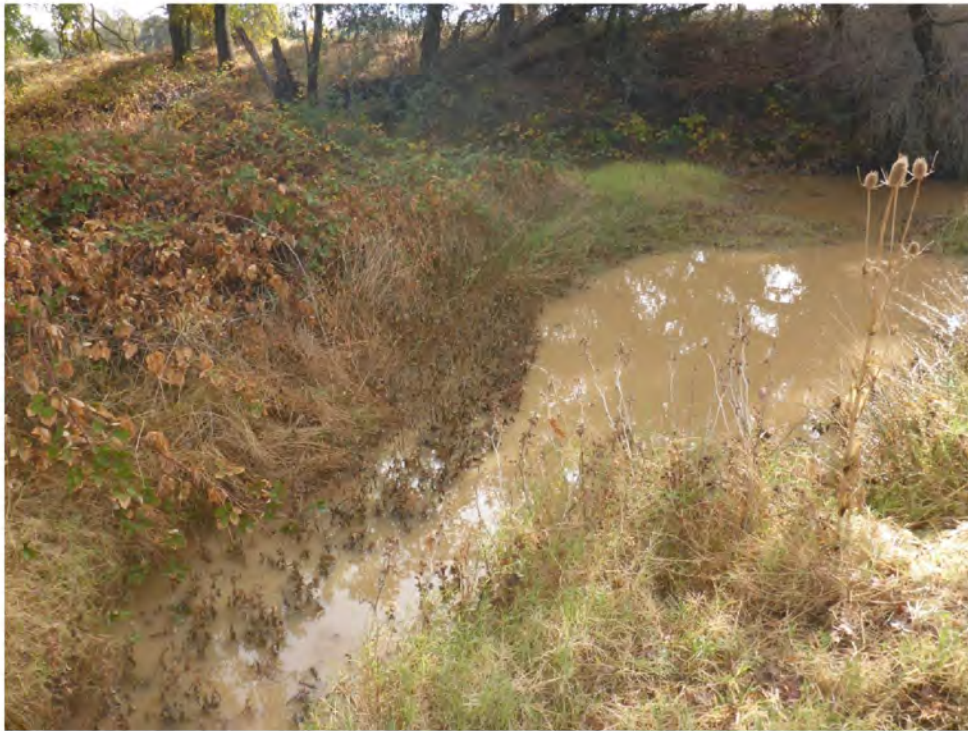
PHOTO 15- Drainage channel with water at point of t-connection to other drainage channel

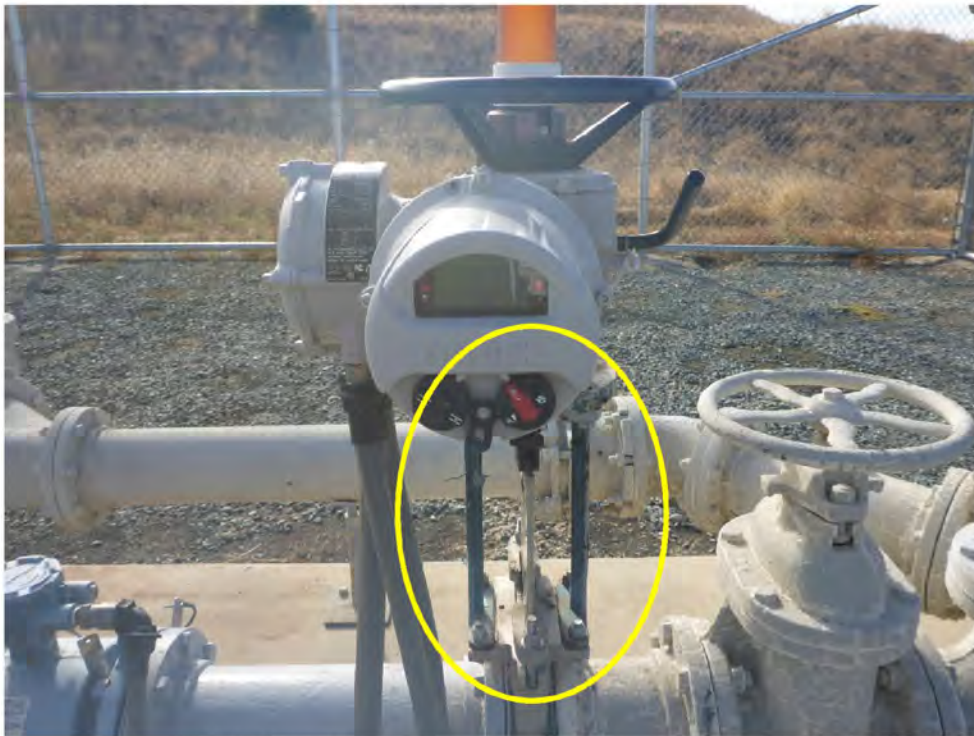
PHOTO 23- Knife gate manually place in the "open" position

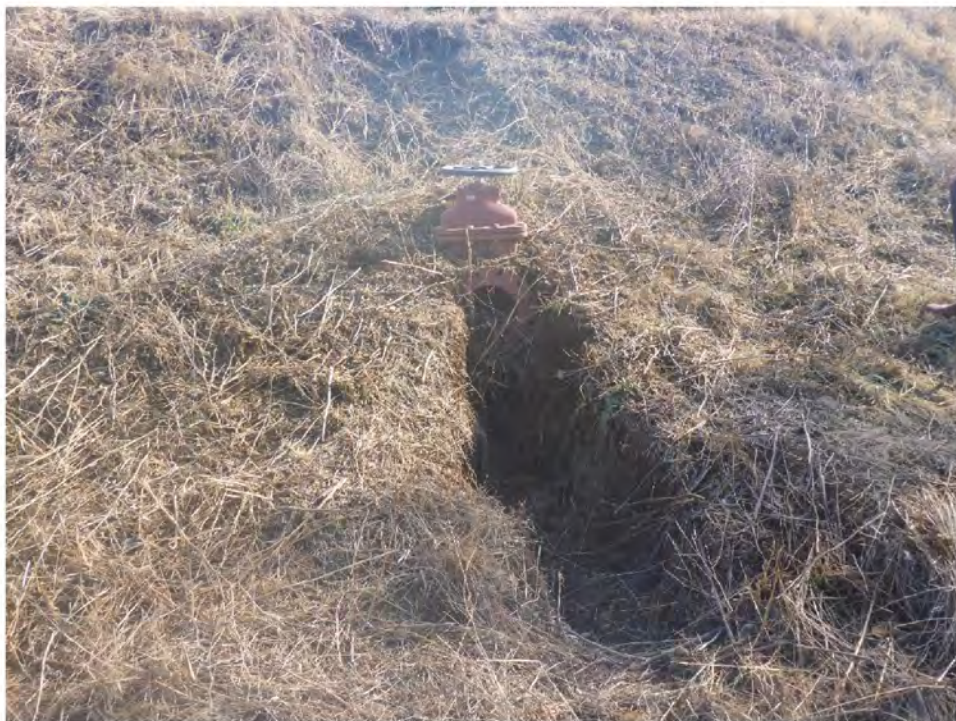
PHOTO 24 – Emergency valve in berm where August 11, 2020 SSO flowed through

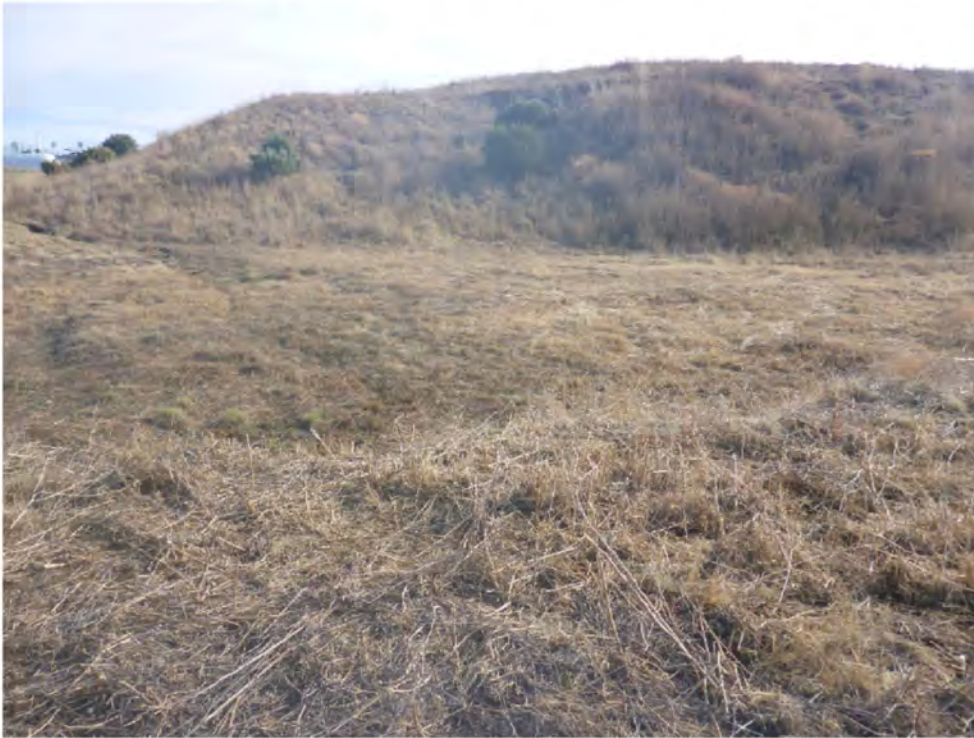
PHOTO 25 – Area August 11, 2020 SSO flowed to

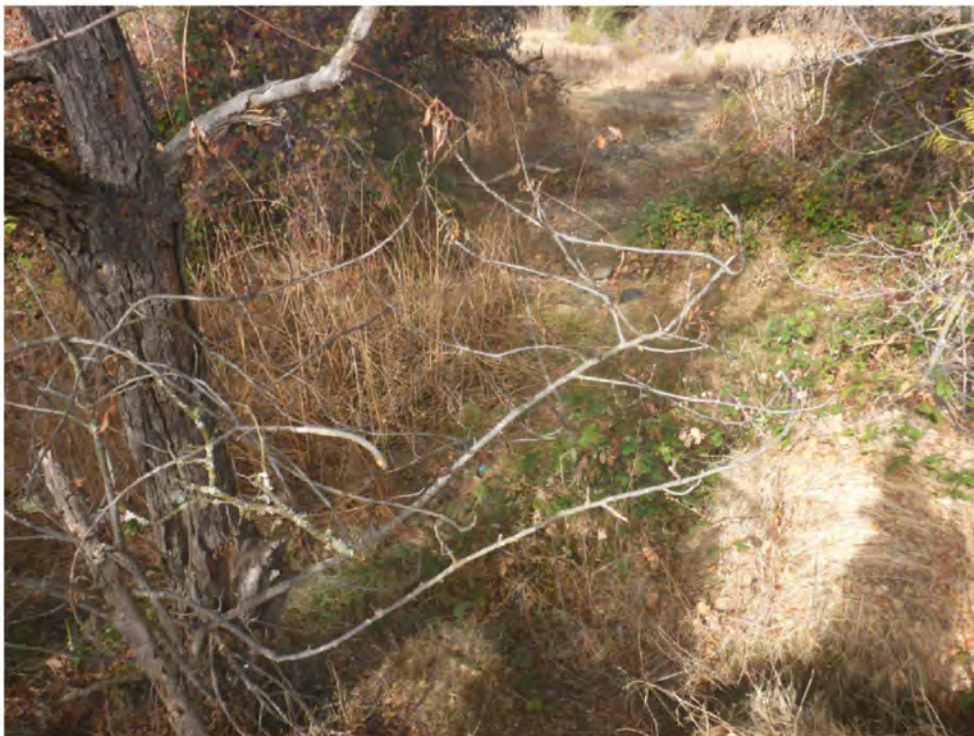
PHOTO 26 – Creek bed where SSO flowed to and fluid was recovered

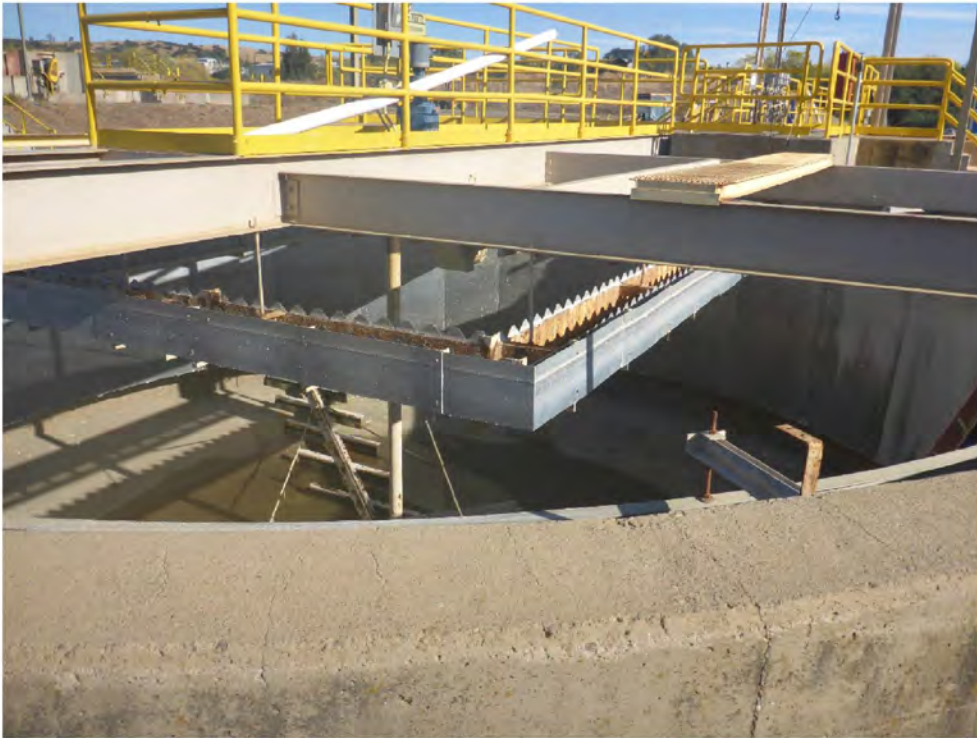
PHOTO 31 – Clarifier #2 (out of service)
